We would like to inform you that Apollo Tyres (Europe) B.V has registered a recall process in Europe, resulting from the use of a contaminated compound in a limited batch of tyres manufactured during week 9 of 2024, some of which might have been mounted on your car. The detail of potentially affected tyres are listed below. We stress that no other tyre sizes are affected by this issue, and no others produced outside week 9 are affected and are not eligible for free replacement.

Enclosure - 1 – Identification

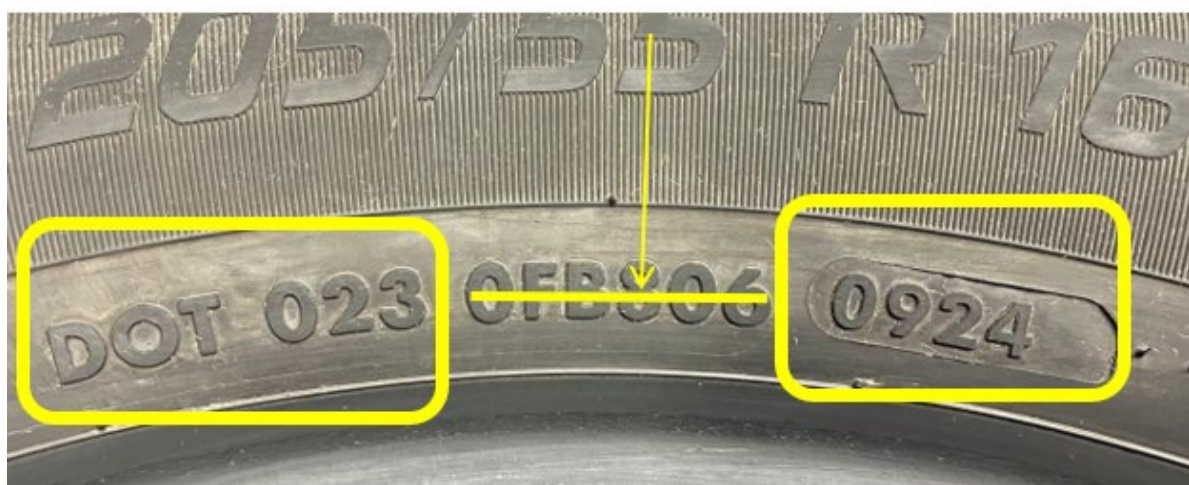
The tyres that need to be segregated can be identified* by the engraving on the sidewall, see the in yellow highlighted information.

- 1- DOT 023
- 2- 0924 (week/ year code)

The information between “DOT 023” and “0924” is not relevant for the segregation.

* Be aware that this full information is only available on one side of the tyre.

In case of the Ultrac, Quatrac Pro+ and Quatrac Pro EV:

→ above information is visible on the outside of the tyre.

In case of the Quatrac:

→ the information for the right fitted tyres is visible on the outside and for the left fitted tyres on the inside.
